2021 PAVEMENT MANAGEMENT REPORT

PREPARED FOR: The Heritage Isles Community Development District

DATE: Thursday, October 7, 2021

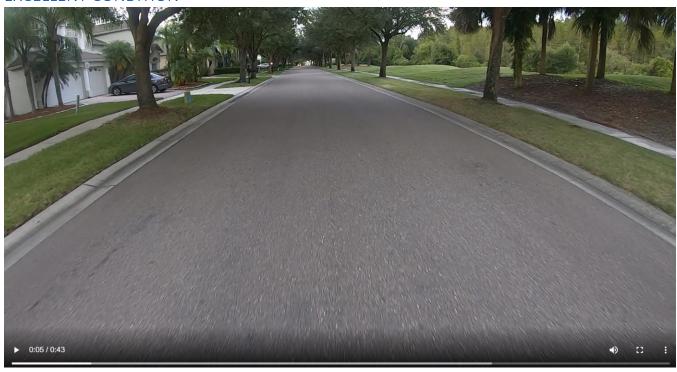
PLANTATION BAY DR | SECTION 07 | PCI 92

EXCELLENT CONDITION

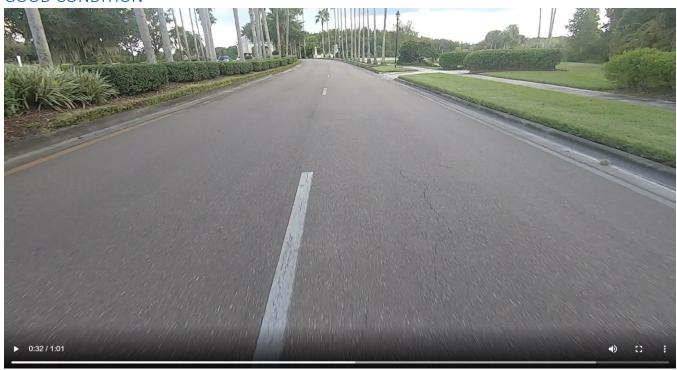
GRAND ISLE DR | SECTION 01SB | PCI

GOOD CONDITION

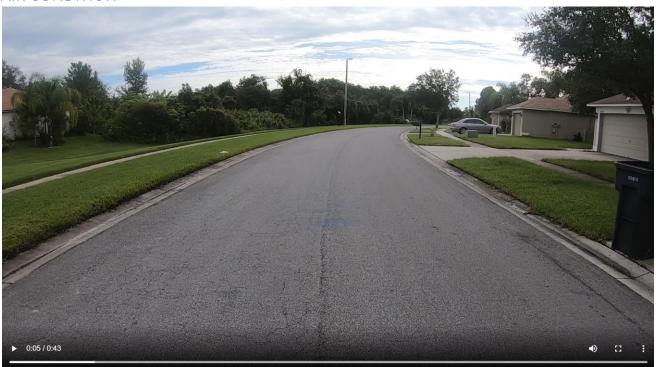
ISLEWORTH AVE | SECTION 03 | PCI 69

FAIR CONDITION

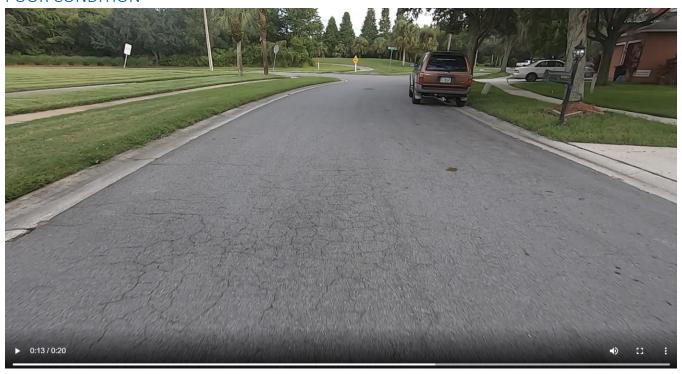
PLANTATION BAY DR | SECTION 01 | PCI 45

POOR CONDITION

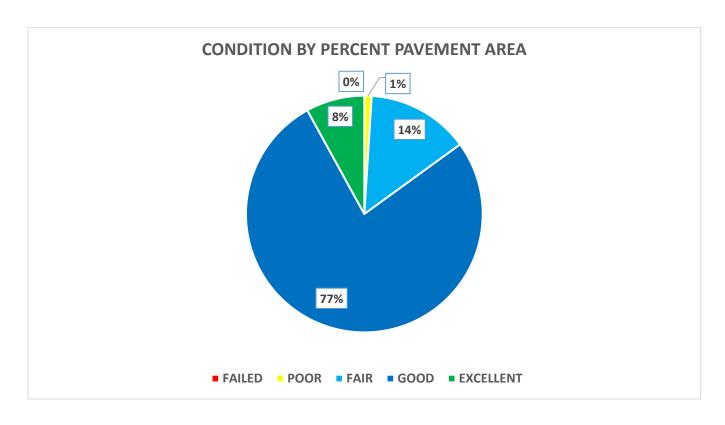
Figure 3. Roadway Conditions by Percent Pavement Area

After completing the 2021 pavement management project, PMG has determined that the average PCI for your roadway network is a 77 and within the GOOD condition category range. Table 2 displays the condition summary data by category across the network, while Figure 3 illustrates the condition by pavement area breakdown in graph form.

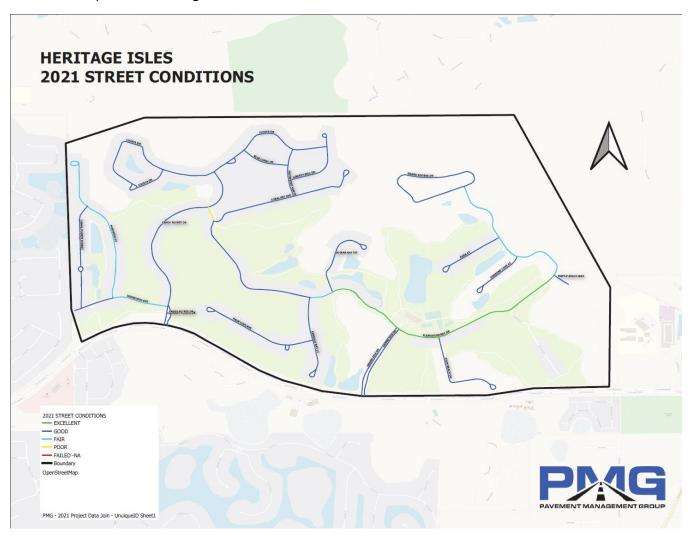
Figure 4. GIS-based Current Roadway Condition Map

PMG maintains a GIS assignment within the PAVERTM software for all sections within the roadway network. This effort allows for pavement management GIS-based maps, such as the current roadway condition map outlined in Figure 4 below.
