2021 PAVEMENT MANAGEMENT REPORT

PREPARED FOR: The Heritage Isles Community Development District

DATE: Thursday, October 7, 2021

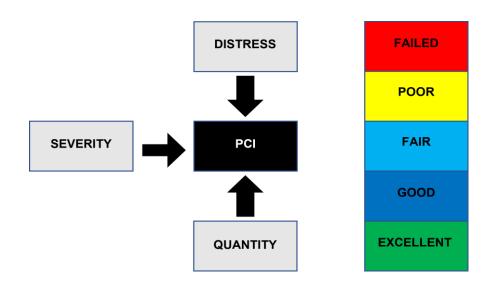
Figure. 2 Factors Determining PCI Value

The PCI is on a 0-100 condition scale, with 0 considered failed and 100 considered excellent. PAVERTM calculates each PCI through the input of distress types, severity levels, and quantities. Figure 2 illustrates the factors that go into the PCI, while Table 1 outlines the five (5) condition categories of the PCI with correlating maintenance recommendations:
